Webster Lake Engineering Feasibility Study

KOSCIUSKO AND WHITLEY COUNTIES, INDIANA

May 18, 2004

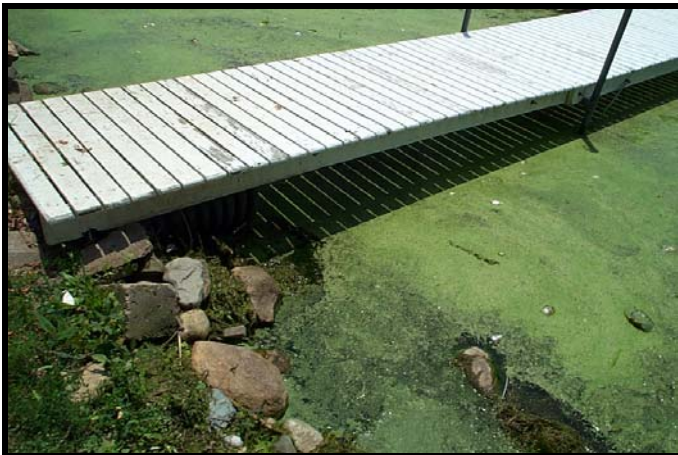
Drain 42 outlet pipe located underneath the dock.

Drain 42: This drain is located opposite 8501 Wesley Lane at the northeast corner of 9th Trail and Wesley Lane. The drain's inlet cover is a 14-inch circular grate located in a yard adjacent to the road. A 12-inch plastic pipe enters the drain from the north draining water from 9th Trail. The origin of this pipe was not located at the time of the survey. The structure of the drain consists of a 14-inch corrugated metal pipe placed perpendicular to the ground's surface, which appears to be free of debris. Water exits the drain through a 12 inch plastic pipe which travels south underneath Wade Lane approximately 300 feet to Webster Lake.

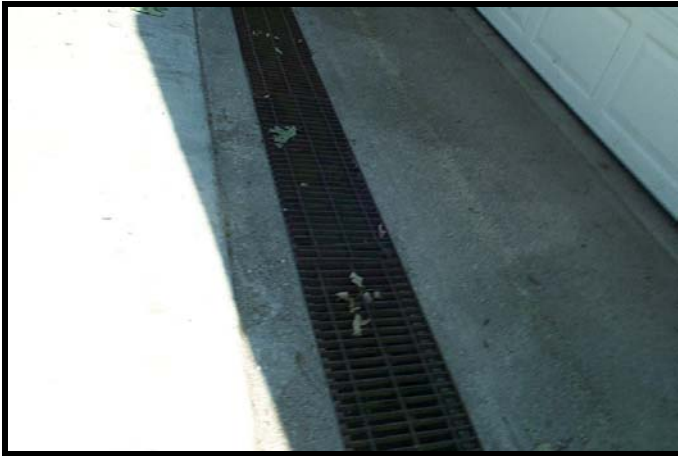
East inlet to Drain 43.

Drain 43: Drain 43 originates as a driveway drain measuring approximately 12 inches in width and running the width of the driveway (approximately 8 feet). Water drains out of the bottom of the grated collection area through three 2-4-inch diameter pipes. A larger 4-6-inch plastic pipe collects drainage from the three pipes and runs southwest to a second inlet. A 14-inch square plastic grated inlet collects water from the house, gutters, and driveway in addition to receiving water from the neighboring driveway drain. Water exits the west drain inlet through a 6-inch plastic pipe and runs south approximately 200 feet to a concrete swale. The concrete swale directs water downhill approximately 25 feet to the lake.

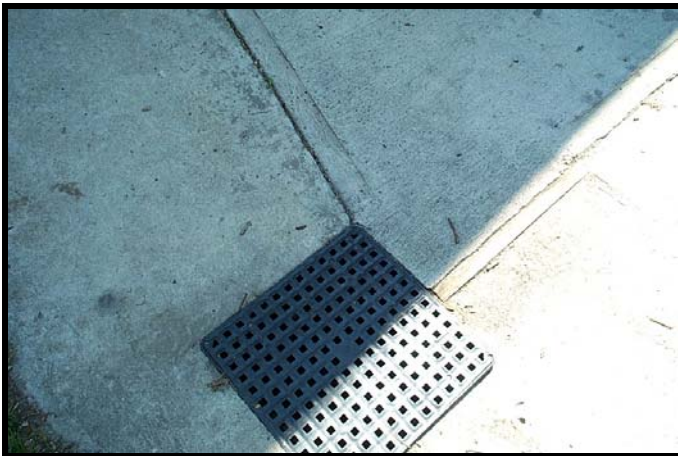
West inlet to Drain 43.

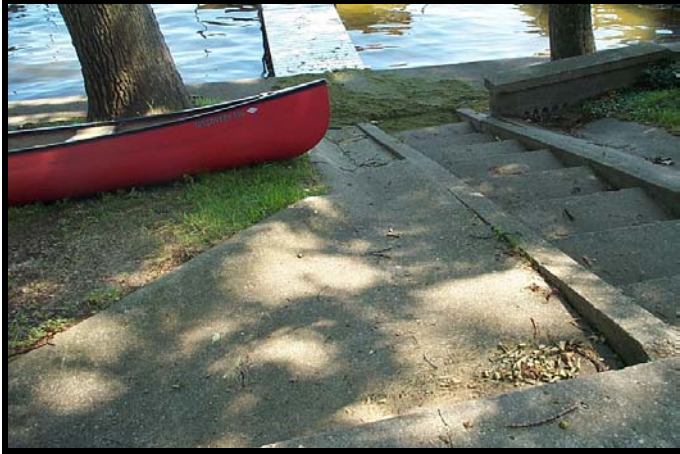
Outlet to Drain 43.

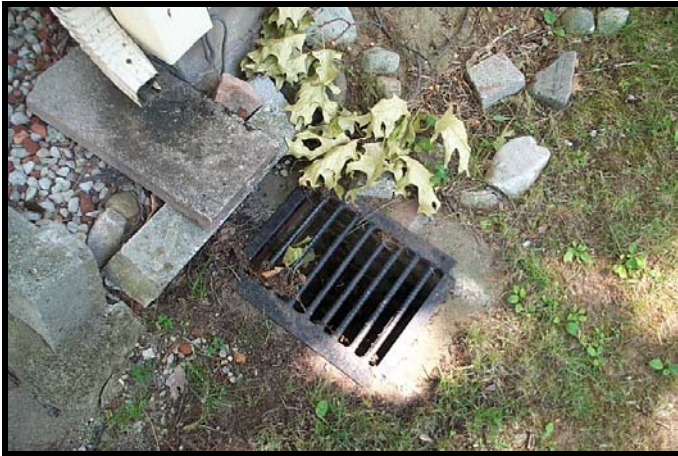
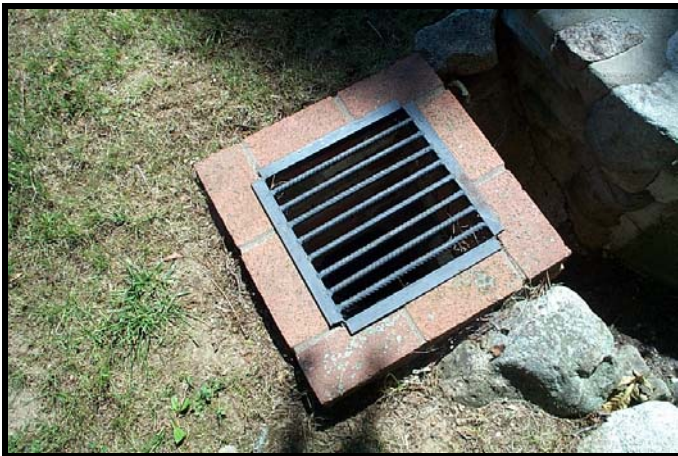
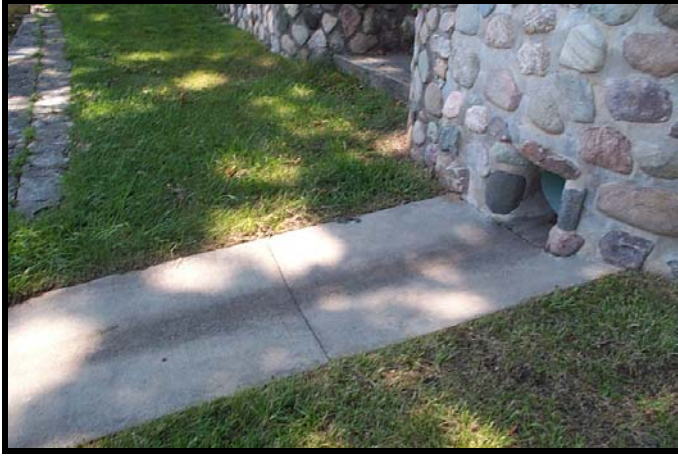
Drain 44: Drain 44 starts as an asphalt-lined swale at the south side of Wade Lane. A 10-inch square inlet collects water from the yard, parking area, and gutter. Water exits the inlet through an 8-inch plastic pipe to the swale. The swale runs approximately 100 feet south between two houses to a 10-inch square brick-lined drain inlet. This inlet receives water from another 8-inch plastic pipe flowing in from the northeast. The origin of this pipe was not located during the site survey. A 12-inch plastic pipe directs water from the brick-lined drain, down the hill, and outlets in a concrete swale approximately 15 feet north of Webster Lake. Water flows from the pipe, through the swale, over the seawall, and into the lake.

Grated inlet for Drain 44.

Grated water collection point for north and northeast drainage to Drain 44.

Concrete swale and plastic pipe directing water from Drain 44 to Webster Lake.

44	concrete swale, 10" square metal grated inlet, and an 8" plastic pipe to an 8" square metal grated inlet; exits through a 12" plastic pipe to a concrete swale	Replace blacktop swale with gravel/cobble infiltration trench or vegetated swale.
45	concrete swale and 3" plastic pipe to concrete swale	Replace cement with gravel/cobble infiltration trench or vegetated swale.
46	two 3" by 8' driveway grates to a 4" plastic pipe	Regular drain cleaning; install StreamGuard.
47	cement depression to a 4" plastic pipe	Regular drain cleaning and maintenance.
48	12" circular cement grated inlet through a 10" plastic pipe to an 18" circular metal grated inlet; exits the drain through a 10" plastic pipe	Clean grating; regular drain maintenance.
49	14" circular metal grated inlet through a 10" corrugated metal pipe to a 10" circular metal grated inlet; exits through an 8" plastic pipe	No recommended action.
50	10" clay tile to an 18" square metal grated inlet to a 10-12" clay pipe	Repair broken tile and fill blow hole.

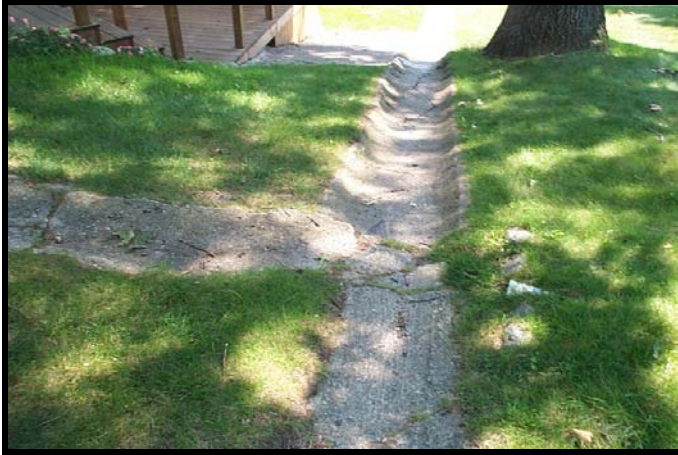
Concrete swale of Drain 45 from house and drain pipe from gutters.

Drain 45: Drain 45 consists of a concrete swale which runs south from Wade Lane. A concrete swale draining areas around a house to the west and a pipe draining water from a house to the east connects with the concrete swale. The concrete swale directs water approximately 200 feet from the side of Wade Lane, between the two houses, down the hill, across a concrete seawall, and into the lake. The property owner has installed a board across the seawall at the lakeshore to prevent water from pooling on the top of the seawall's surface during storm events.

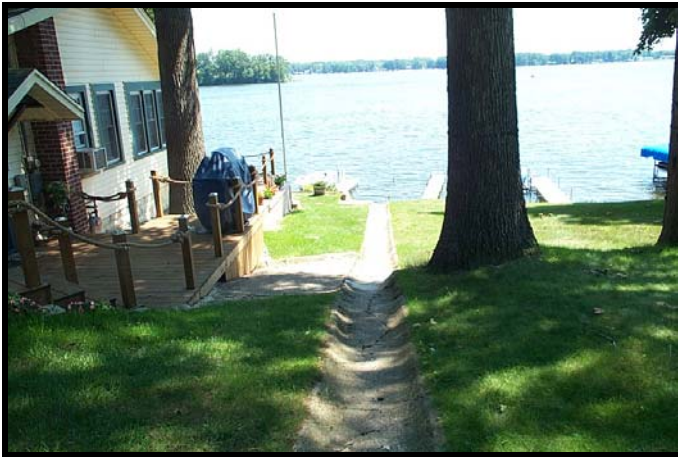
Concrete swale leading from Wade Lane to Webster Lake.

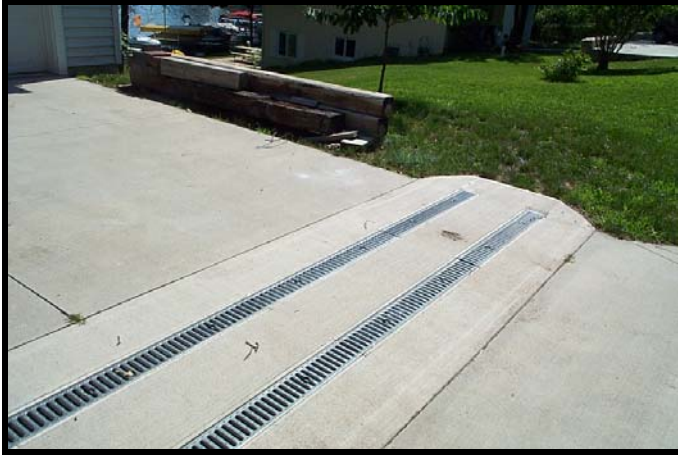
Drain 46: Drain 46 originates as two parallel grated driveway drains immediately south of Wade Lane. The drains measure approximately 3 inches in width and span the entire width of the driveway. Water from the two drains collects in a 4-inch plastic pipe which runs underground around the house, down the hill, and into Webster Lake.

Grated inlets to Drain 46.

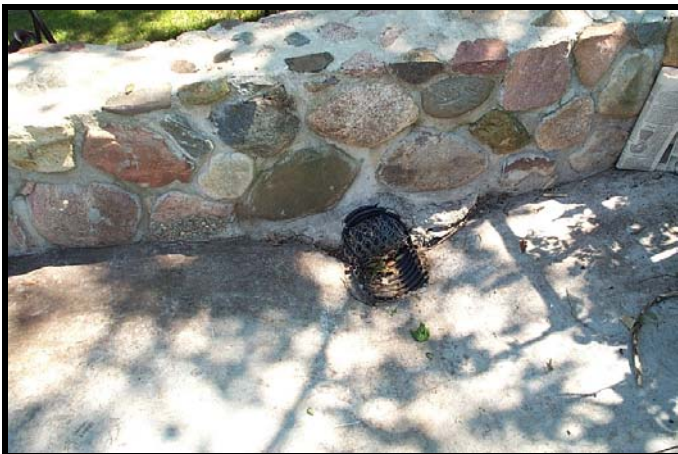
Drain 47: Water from a driveway immediately south of Wade Lane collects in a low spot in the concrete before emptying into a 4-inch plastic pipe. The landowner placed wire in the drainage pipe opening to limit the amount of sediment and debris entering the pipe. The pipe runs underground approximately 400 feet south to exit through a concrete seawall at the lakeshore.

Inlet to Drain 47.

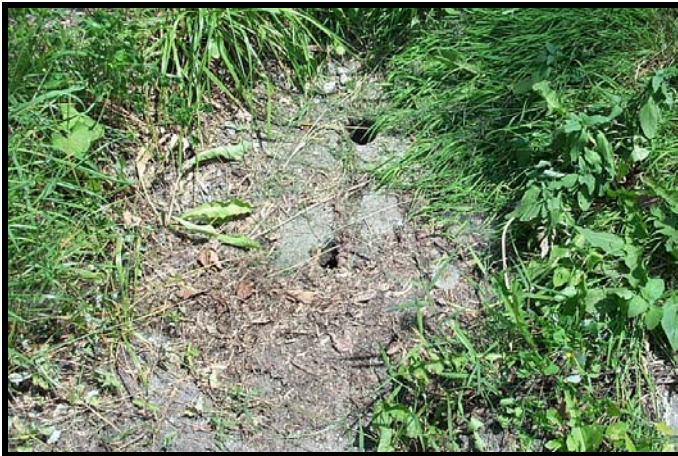
Drain 48: This drain system collects water along the length of 5th Trail. The northern grated inlet is located on the east side of the road at 6652 5th Trail. The grate is a 12-inch circular cement slab with two visible drain holes. The grate is covered almost entirely covered with grass clippings and dirt. It could not be determined whether additional pipes carry water into this drain. Additional inlets north of this one along 5th Trail could not be found at the time of the survey. It is believed that water exits the drain to the southwest traveling through a 10-inch plastic pipe underneath 5th Trail to a second grated inlet. The southern inlet is located on the west side of 5th Trail immediately south of the driving leading to 6641 5th Trail. This inlet is covered by an 18-inch grate. In addition to the 10-inch pipe from the northern inlet, a 4-6-inch plastic pipe carries water into the drain from the west. The origin of this pipe was not located during the survey. A 10-inch plastic pipe exits the drain in a south-southwesterly direction. It is believed that the pipe carries water from the southern inlet approximately 600 feet to Webster Lake. Additional inlet openings could not be located between the southern drain at 6641 and the outlet pipe indicated by the landowner at the lake. The 10-inch plastic pipe outlets on the west side of Frost's pier at 8123 Wade Lane. Mr. Frost indicated that the outlet pipe carries water from the entire length of 5th Trail.

Northern grated inlet to Drain 48.

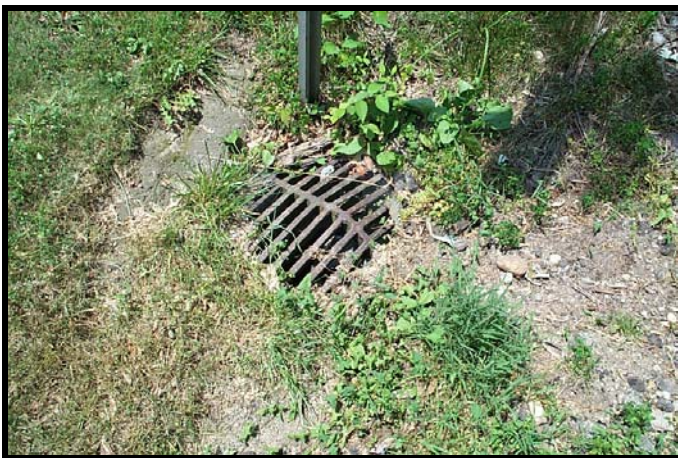
Southern grated inlet to Drain 48.

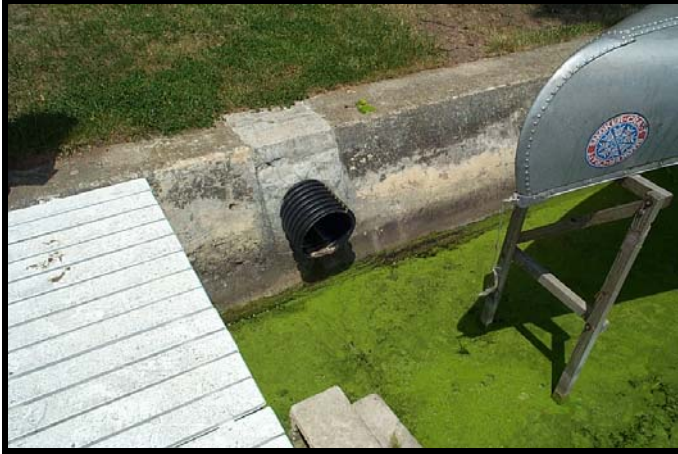
Outlet of Drain 48.

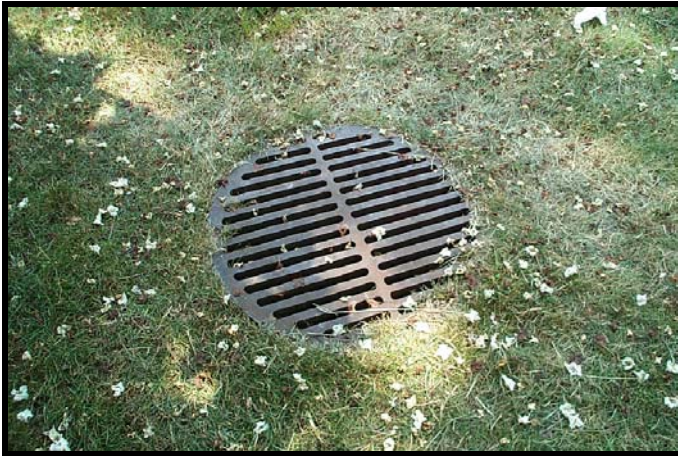
Drain 49: The drain is located along Wade Lane immediately west of 5th Trail. The drain's inlet is covered by a 14-inch circular grate. No pipes carrying water into the drain were identified at the time of the survey. A 10-inch corrugated metal pipe carries water south underneath Wade Lane to a second drain. The drain is located immediately west of the driveway for 8123 Wade Lane. This inlet is a 10-inch circular grate. Mr. Frost indicated that water travels through a plastic 8 inch pipe located west of the sidewalk adjacent to his house before flowing downhill approximately 300 feet to Webster Lake. Water exits the drain through the same 8-inch plastic pipe located in the seawall east of Mr. Frost's pier.

Northern inlet to Drain 49.

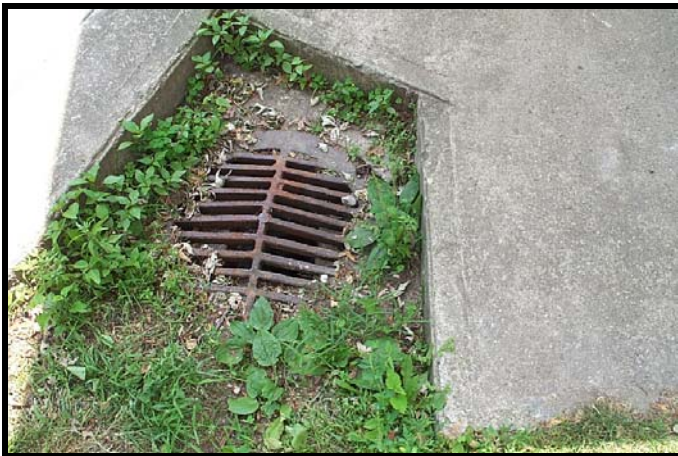
Southern inlet to Drain 49.

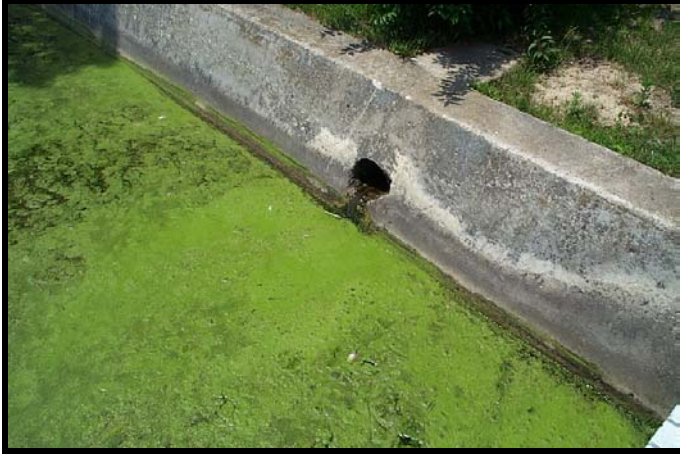
Outlet to Drain 49.

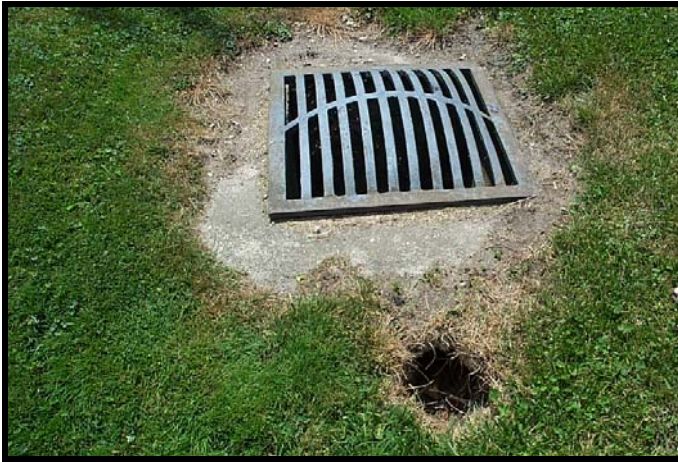
Drain 50: The drain is located at the southeast corner of the intersection of Wade Lane and 2nd Trail. The drain's inlet is covered by an 18-inch square grate. A 10-inch clay tile carries water from the north into the drain. The tile is broken as evidenced by the blow out to the north of the drain. The origin of this pipe was not determined during the survey. Additional drain inlets north or east of this drain could not be found either; therefore, it could not be determined at the time of the survey whether additional pipes carry water into the drain. Water exits the drain through a 10-12-inch clay tile which travels west approximately 150 feet to Webster Lake. The pipe travels through a concrete seawall before reaching the lake.

Grated inlet to Drain 50. Note the broken tile as evidenced by the blow hole located to the north drain.

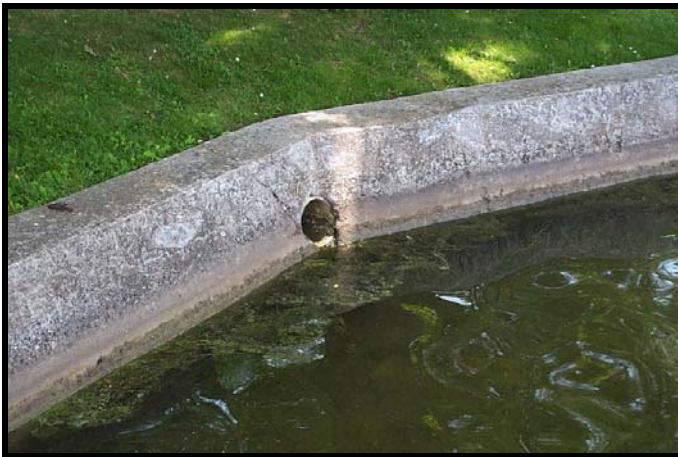
Outlet to Drain 50.

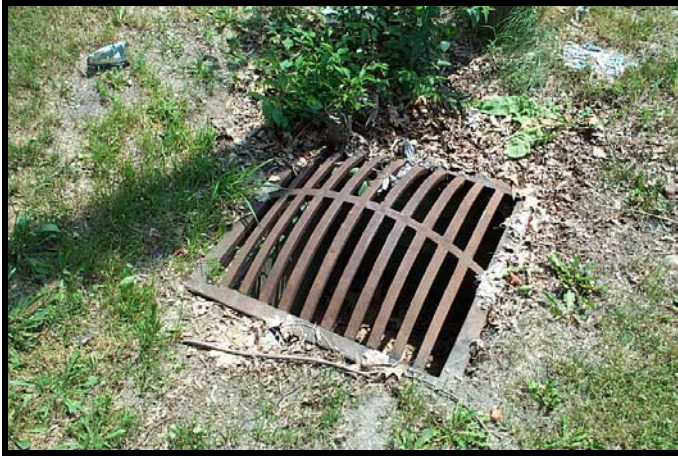
Drain 51: The drain is located at the southeast corner of the intersection of 1st and 3rd Trails. The drain's inlet is covered by an 18 inch grated metal grate. Water collects in the concrete drop structure located beneath the drain. The drop structure was partially filled with sediment and debris at the time of the survey. Leaves, grass clippings, and debris were collecting in the area around the grate at the time of the survey. Water exits the structure through a 10-inch clay pipe which travels southwest underneath 1st Trail to a second inlet. The second inlet is covered by an 18-inch square metal grate. The inlet's concrete drop structure was partially filled with sediment and debris at the time of the survey. A 10-inch clay pipe carries water from the structure southwest approximately 200 feet to Webster Lake. Water flows from the pipe through a concrete seawall and into the lake.

Northeast inlet to Drain 51.

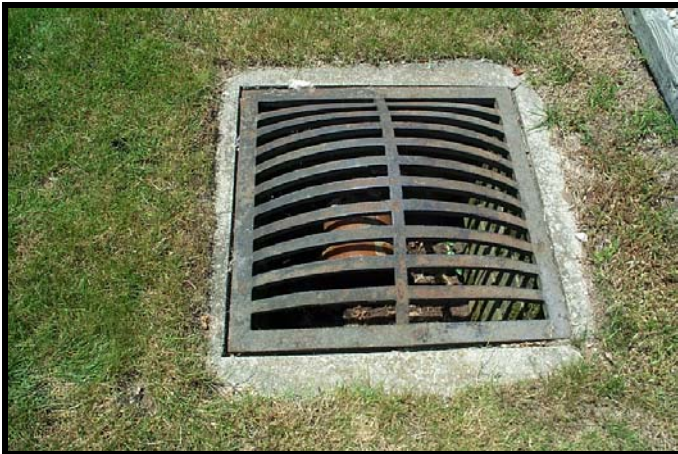
Southwest inlet to Drain 51.

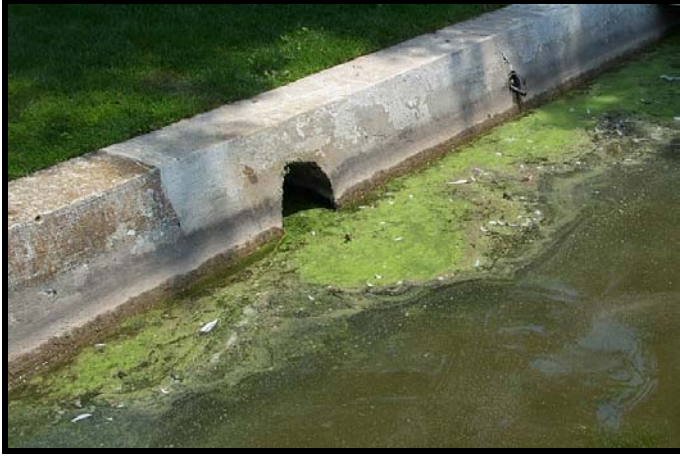
Outlet to Drain 51.
